Master Thesis, Department of Geosciences

# **Spatial and temporal analysis of Holocene coastal development: applications to erosion assessment and cultural heritage mitigation in Svalbard**

Master Thesis in Geosciences

Discipline: Physical Geography, Hydrology and Geomatics

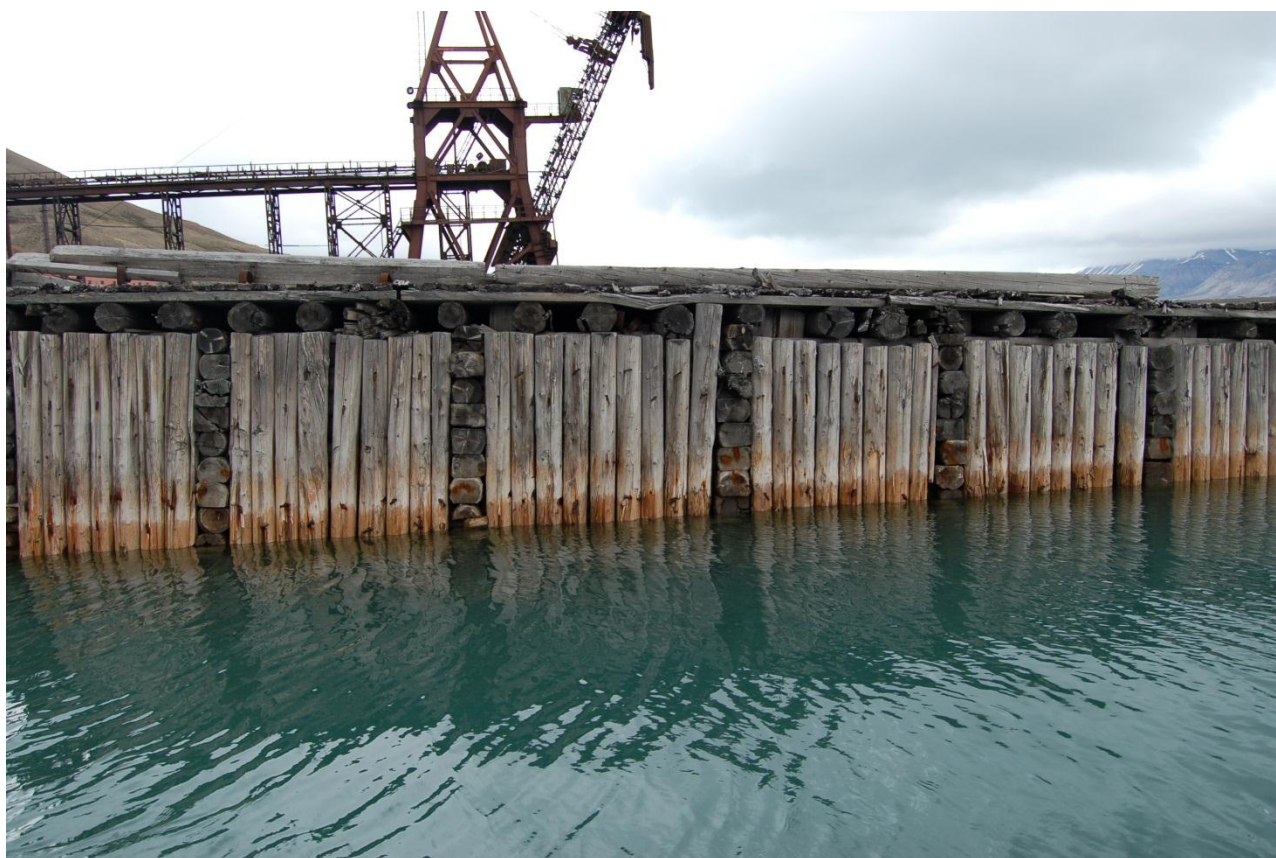
Figur 47      Visualisering: Kaikonstruksjon i Pyramiden etter senkekasse-prinsippet.
